**CONSUMER PROTECTION & SAFETY DIVISION
CALIFORNIA PUBLIC UTILITIES COMMISSION**

**INCIDENT INVESTIGATION REPORT
ON
RANCHO CORDOVA
EXPLOSION AND FIRE**

San Francisco, California
November 10, 2010

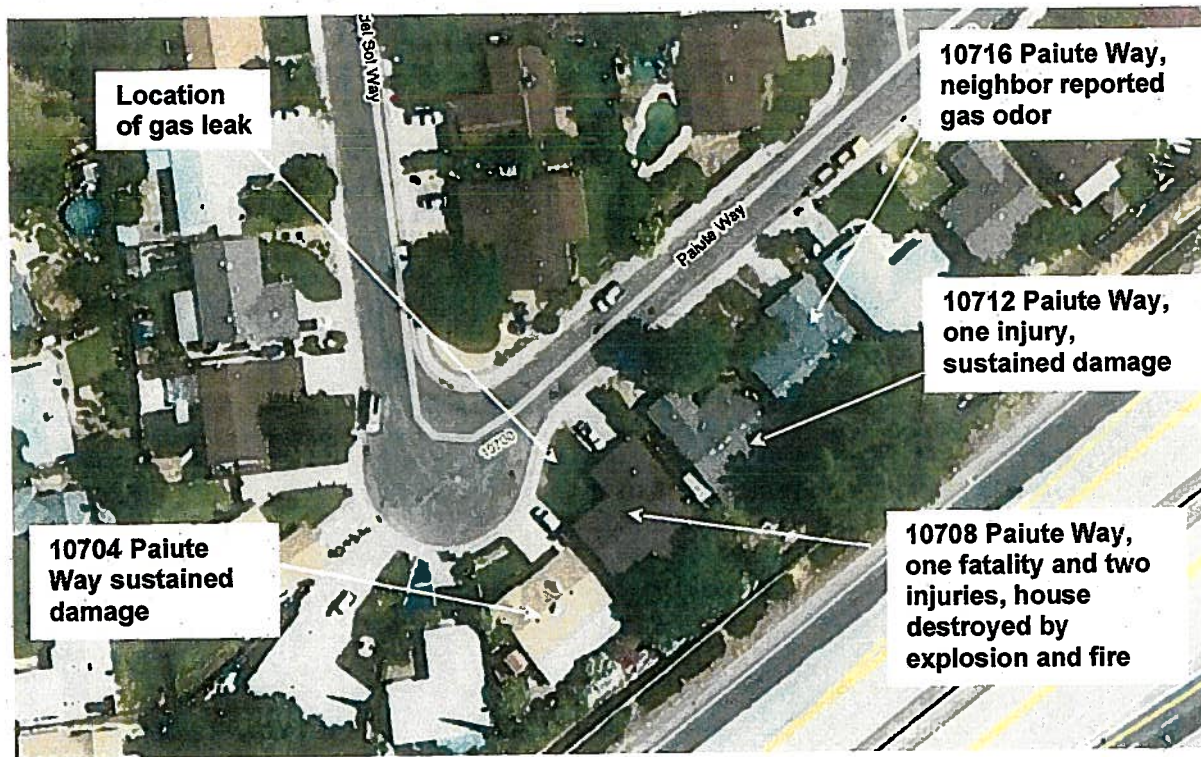
Figure 1 - Aerial View of Incident Location

The explosion occurred at approximately 1335 hours, before the leak investigator could find the leak source. Figure 1, titled *Aerial View of Incident Location* shows the location of the gas leak and relationship of all the houses involved in the incident. The ignition source for the explosion appears to be a lighter that the granddaughter "flicked" at the time of the explosion to light a cigarette. (Appendix A and B)

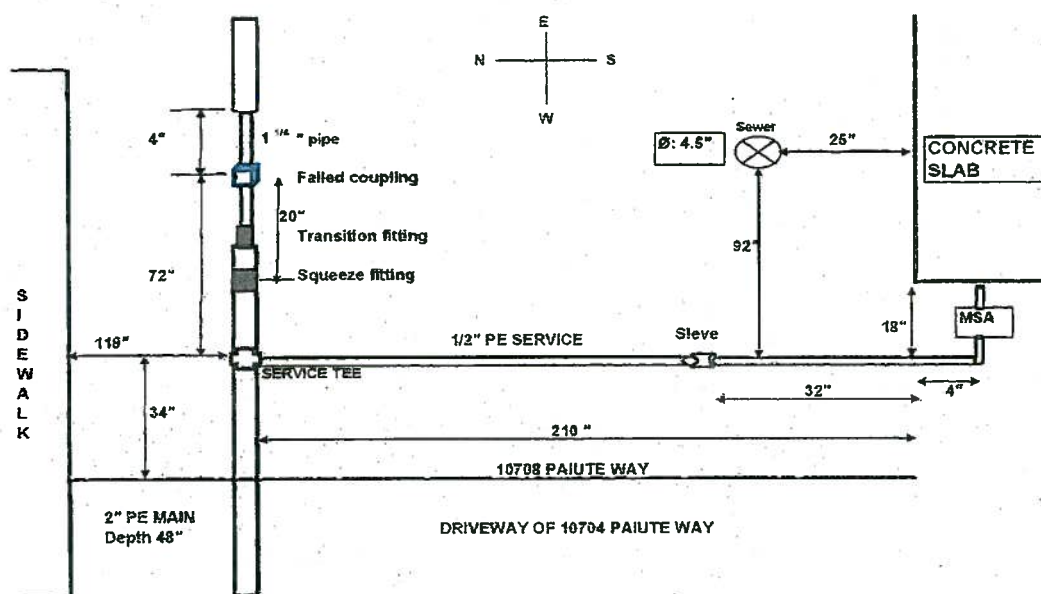
Figure 3 - Schematic of Incident Piping

On December 29, 2008, PG&E dug a trench, at 10708 Paiute Way where the patch of dead grass was located and exposed a 2-inch plastic main pipeline which consisted of a 2-inch to 1¼-inch transition (reducer) fitting, a short section of 1¼-inch pipe, and a 1¼-inch repair coupling. Figure 3, *Schematic of Incident Piping*, shows the orientation of the main pipe, repair, transition and west reducer coupling, and service line that were exposed.

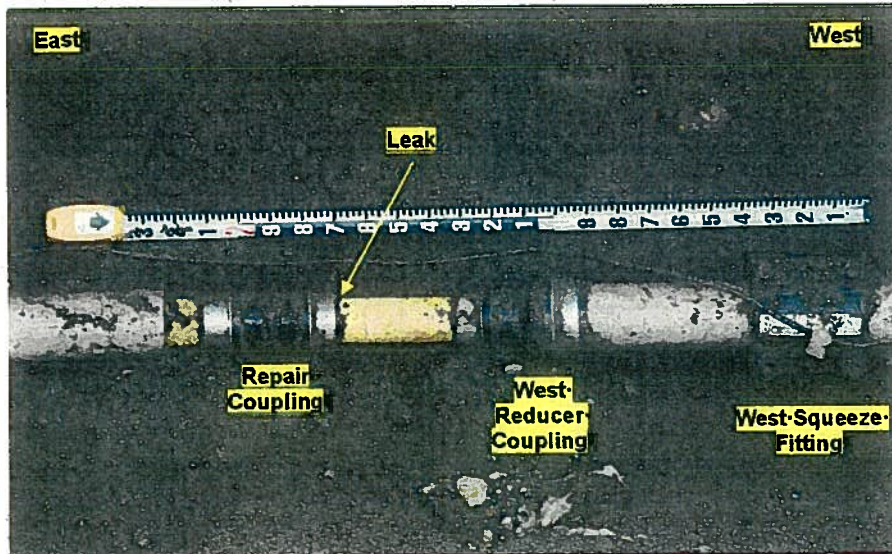
Figure 4 - Exposed Piping

On December 29, 2008, PG&E pressure tested the main pipeline and service lines separately with air in order to find the location of the gas leak. During the pressure test the west end of the repair coupling started leaking air excessively that showed the location of the gas leak where a 5.5 inch section of the 1 1/4-inch diameter repair pipe, that was between the repair coupling and reducer coupling, was found almost completely detached as can be seen from Figures 4 and 5, titled *Exposed Piping* and *Piping Removed From Ground* respectively.

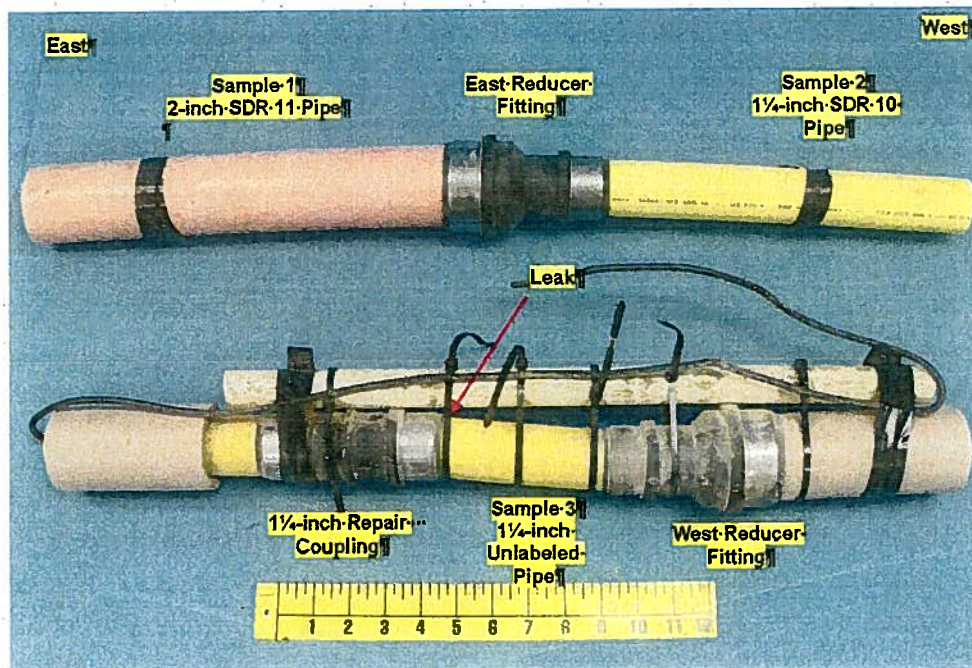
Figure 5 - Piping Removed From Ground

The materials retrieved from the excavation site from east to west shown in Figure 5 are as follows:

- Original 2-inch Aldyl-A PE tan color main pipe (Sample 1)
- Squeeze fitting (east),
- MetFit 2-inch to 1 1/4-inch reducer fitting (east),
- 256-inch section of 1 1/4-inch PE yellow pipe (Sample 2) inserted into the original 2-inch Aldyl-A PE main,
- MetFit 1 1/4 -inch repair coupling where the leak was found,
- Approximately 5.5-inch piece of 1 1/4-inch PE yellow pipe (Sample 3),
- MetFit 1 1/4-inch to 2-inch transition fitting (west),
- Squeeze fitting (west)
- Original 2-inch Aldyl-A PE tan color main pipe.

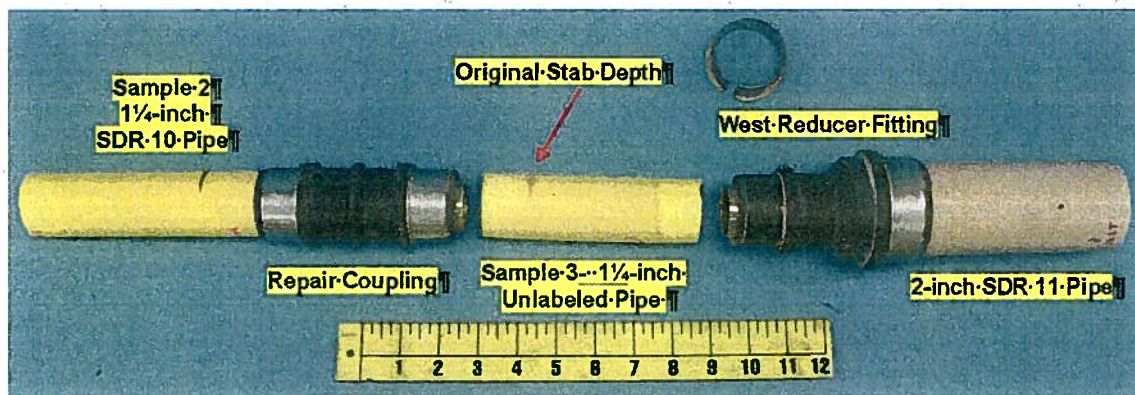
Figure 6 - Close-Up of Failed Pipe

Figure 6, titled *Close-Up of Failed Pipe*, shows there was a red line on the 1¼-inch yellow pipe between the repair coupling and the west reducer fitting. The red line indicated the original stab depth of the pipe into the repair fitting which was marked by the repairman in 2006 to show how far the end of replacement pipe should be seated inside the coupling. The east end of the short segment of pipe (Sample 3) got separated from west end of the repair coupling and started to leak. (Appendix E)

The cause of the gas explosion and fire was the gas leak on the main PE gas pipe located in the front yard of 10708 Paiute Way, Rancho Cordova. The gas leak was caused when a segment of yellow 1¼-inch IPS PE pipe separated from a 1¼-inch IPS coupling. The 1¼-inch pipeline and coupling were installed on September 21, 2006 to repair a gas leak. The pipeline installed was not approved for gas usage according to ASTM D 2513 standards. The leaking gas migrated into the house at 10708 Paiute Way, ignited and caused the explosion and fire. CPD also found that PG&E had inadequate rules or implementation of the rules to timely deal with a gas leak such as occurred in Rancho Cordova, so as to promptly find and assess the leak and to prevent harm to life and property.

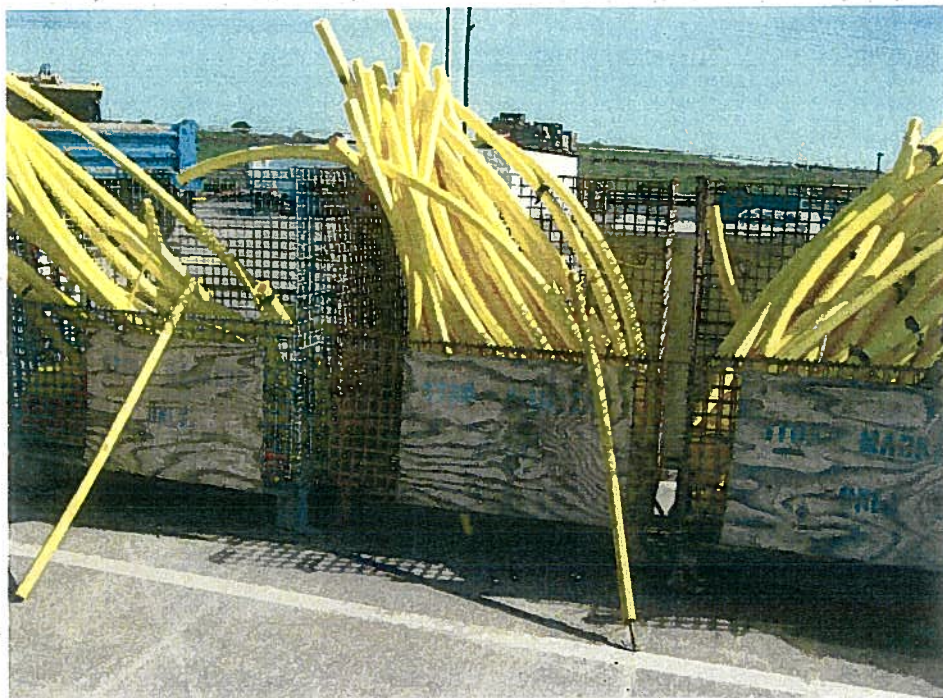
Figure 7 - Stub Marker Bins

Markers Only” at PG&E’s Sacramento Division Maintenance Yard, shown in Figure 7, title *Stub Marker Bins*. Because the PG&E pipe that failed in 2008 in Rancho Cordova was also unmarked, CPD provided the information to Mr. Gunther of NTSB and the pipe segments were sent to NTSB’s laboratory for testing. According to PG&E’s explanation and CPD’s investigation, for a significant time period, the Sacramento Division had a practice of using scrap pieces of pipe which were stored in Stub Marker Bins to mark the ends of gas service stubs. The repairman who performed the pipeline repair at 10708 Paiute Way, Rancho Cordova in 2006, confirmed this practice. The packing pipe, shown in Figure 8, titled *Stack Piping Used To Support Pipeline Coils*, was used to stabilize the stack and protect the pipe coil. The packing pipe was typically disposed of in a trash bin when PG&E received the shipment at the local headquarters. (Appendix D and H)

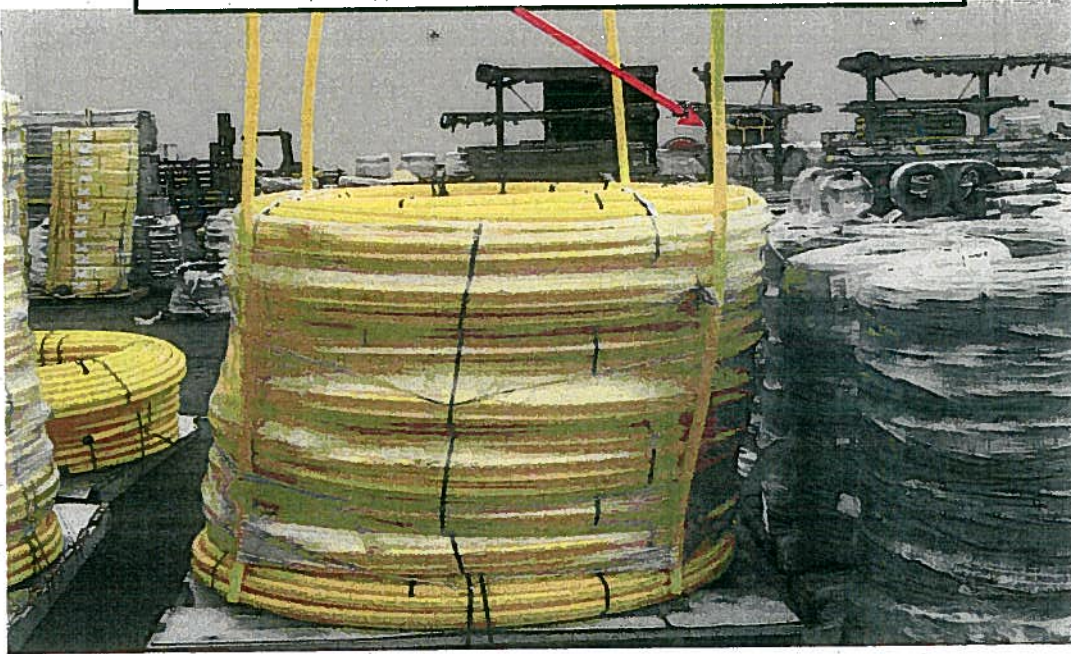
Figure 8 - Stack Piping Used To Support Pipeline Coils

Four vertical segments of stack piping used to support the pipeline coil during transport to PG&E

According to JMEagle (formerly US Poly and Uponor), the pipeline manufacturer, the stack piping used to stabilize the coils (silo) of plastic pipe, is made from the same resin and on the same equipment as the plastic pipe approved for gas usage. They are produced during the start up process before the product achieves the required dimensions. They are produced with no markings in order to make the packaging pipe segments distinguishable from the finished specification pipe product so that they would not be mistakenly installed. The stack piping is not intended to be used to transport gas because its specifications do not match the ASTM D 2513 standards. Therefore, it is unlawful to use the stack piping to transport gas. (Appendix K)
